Spokane River Centennial Trail

Six Year Maintenance Plan
2016 – 2022 (2018 Update)

Produced by and for Centennial Trail Coordinating Council
Approved & Adopted: September 5th, 2018

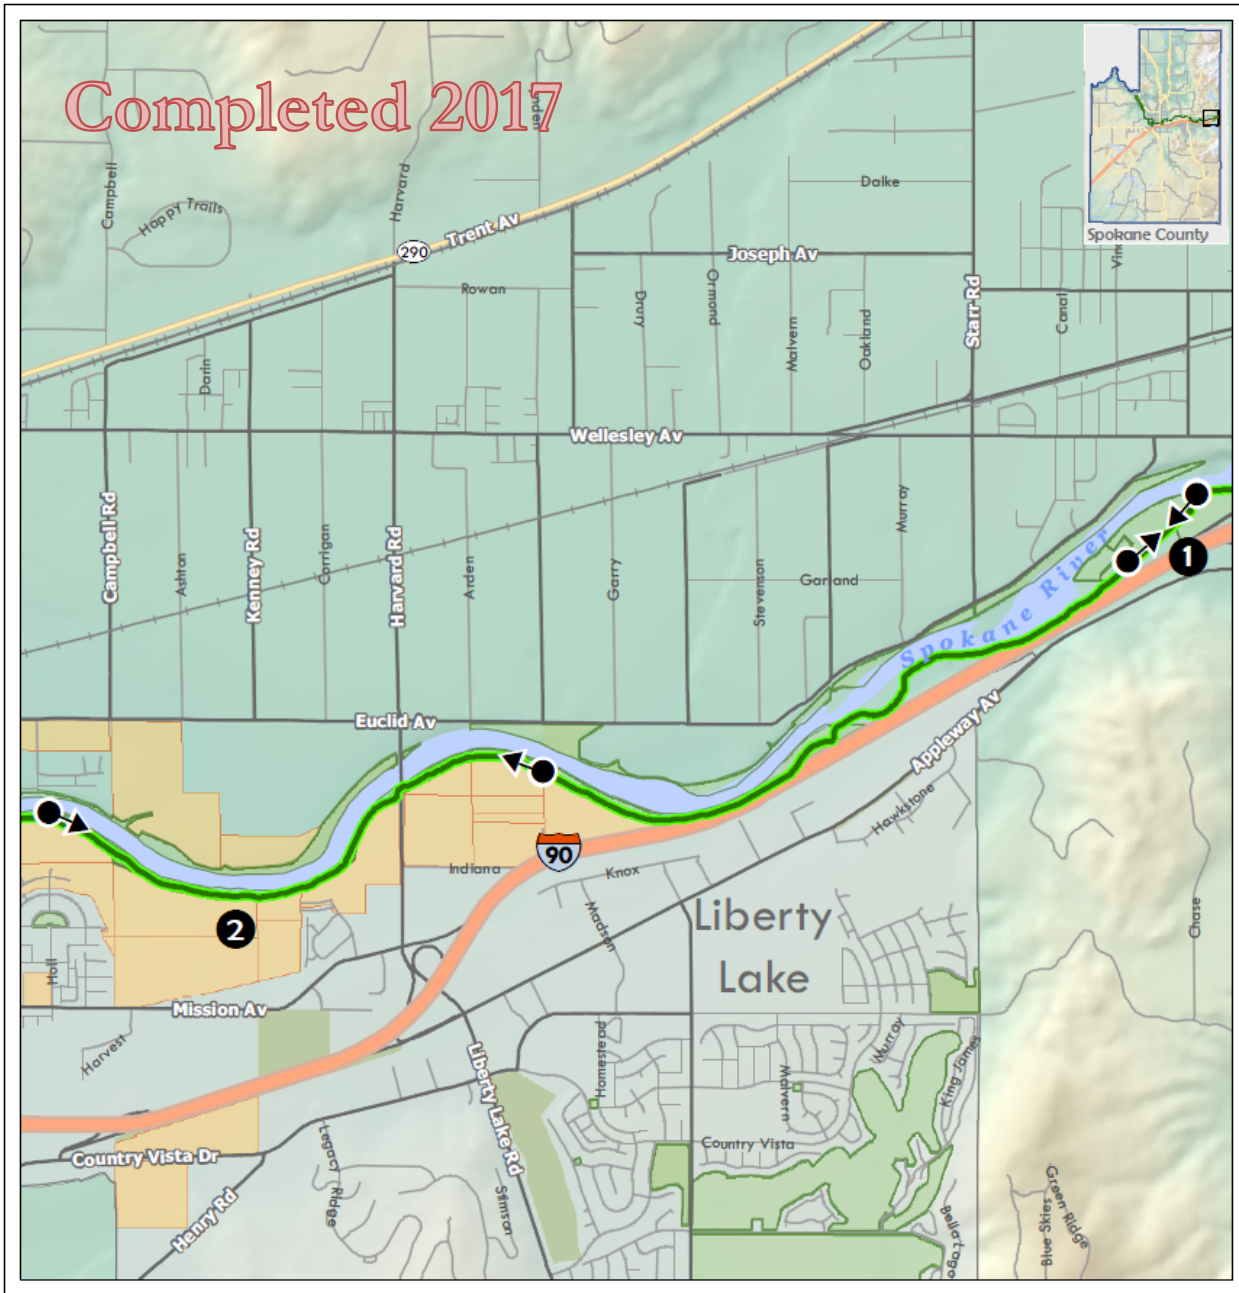
Maintenance Repairs Projects 1 & 2

- Maintenance Project**
- 1 Project 1 MP .86 - 1.17
Crack seal concrete panels.
Estimated Cost:
 - 2 Project 2 MP 3.6 - 5.6
Repair corrugations and bulges.
Estimated Cost:

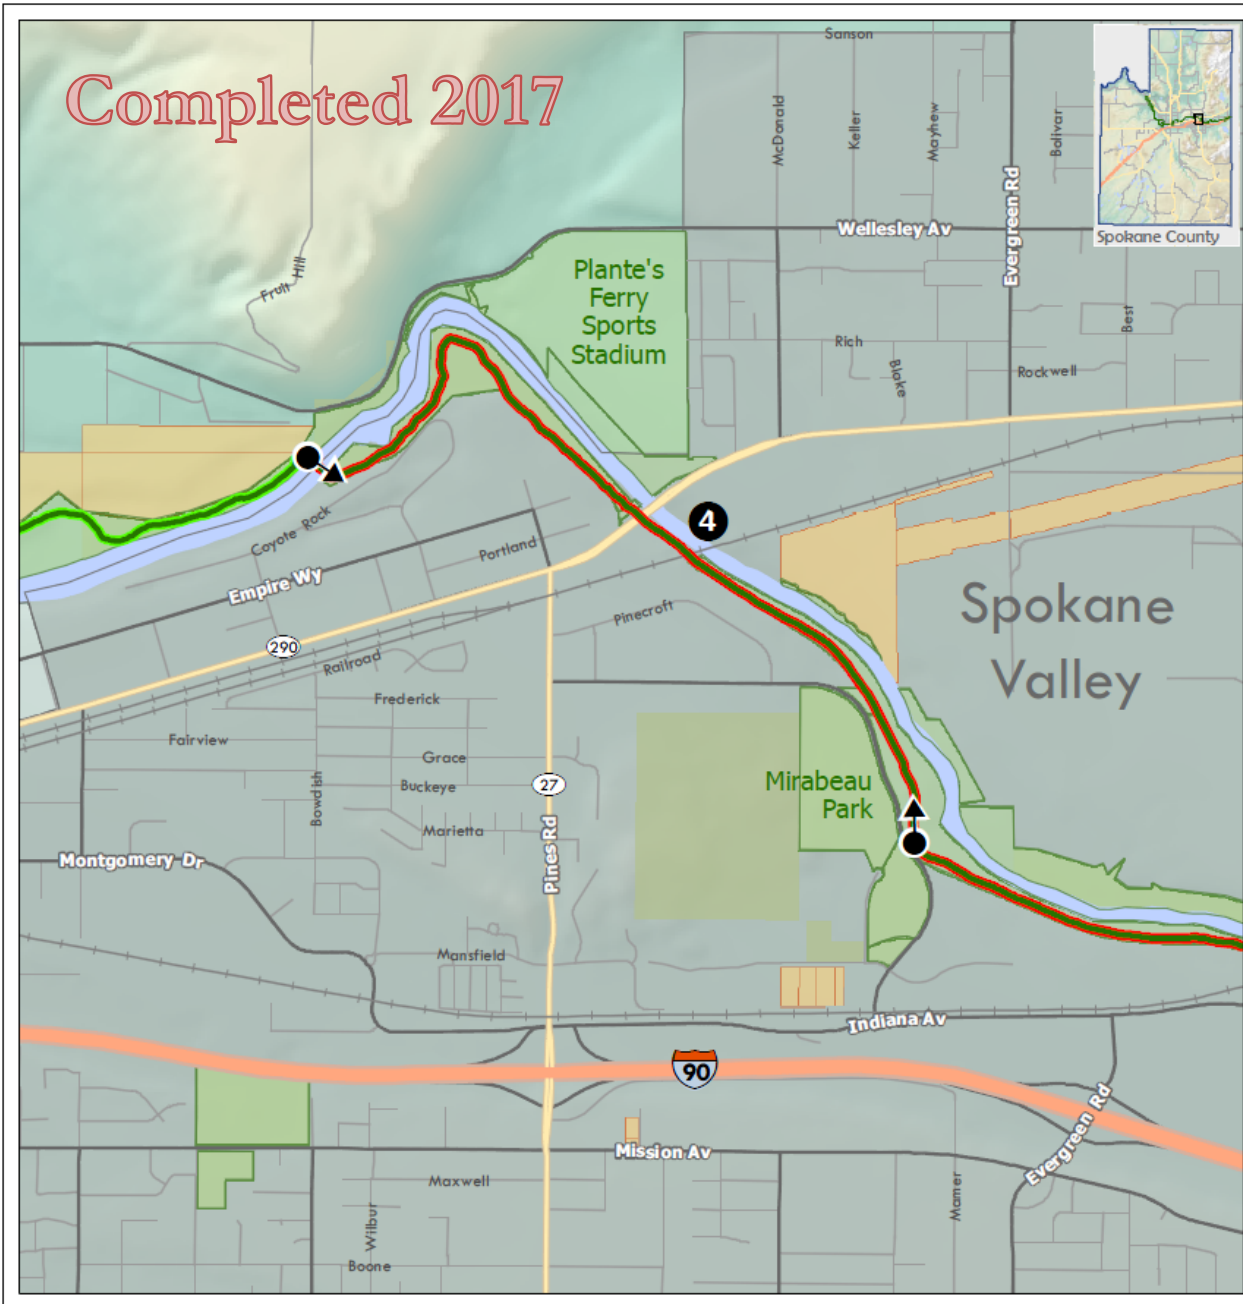
Maintenance Repairs Project 4

Repair bulges, humps, and tree root damage on trail. Joint fill on Denny Ashlock Bride. Eliminate rocks washing onto trail.

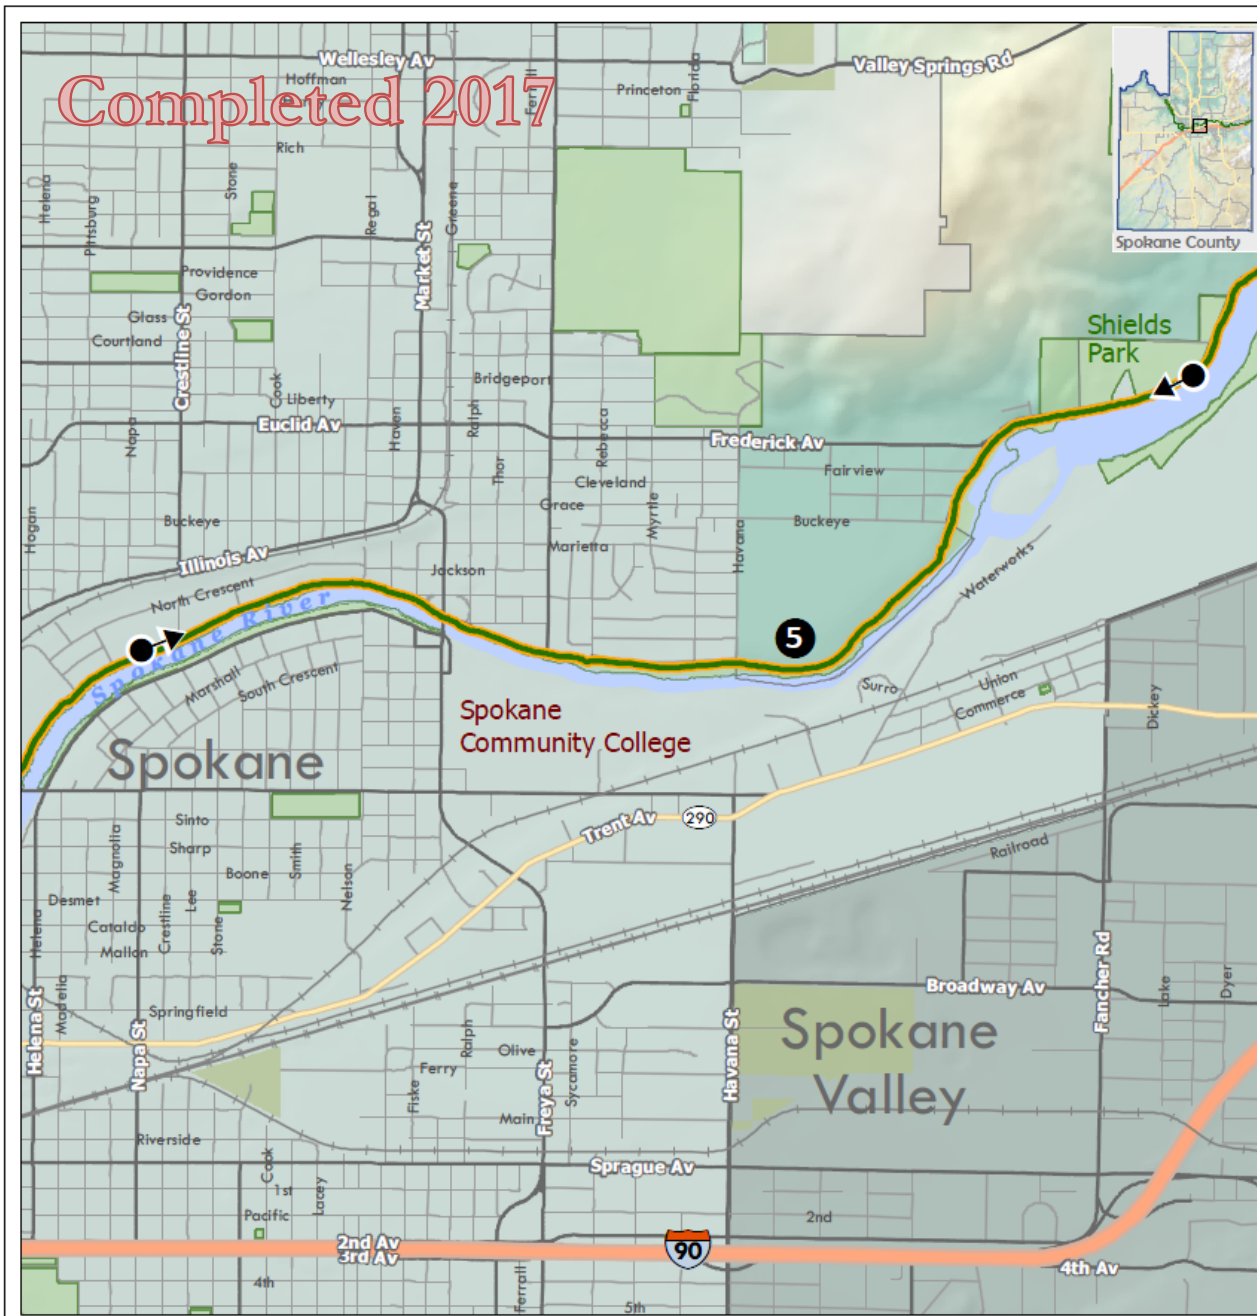
Maintenance Repairs Project 5

Repair corrugations, waves, and humps along entire section.

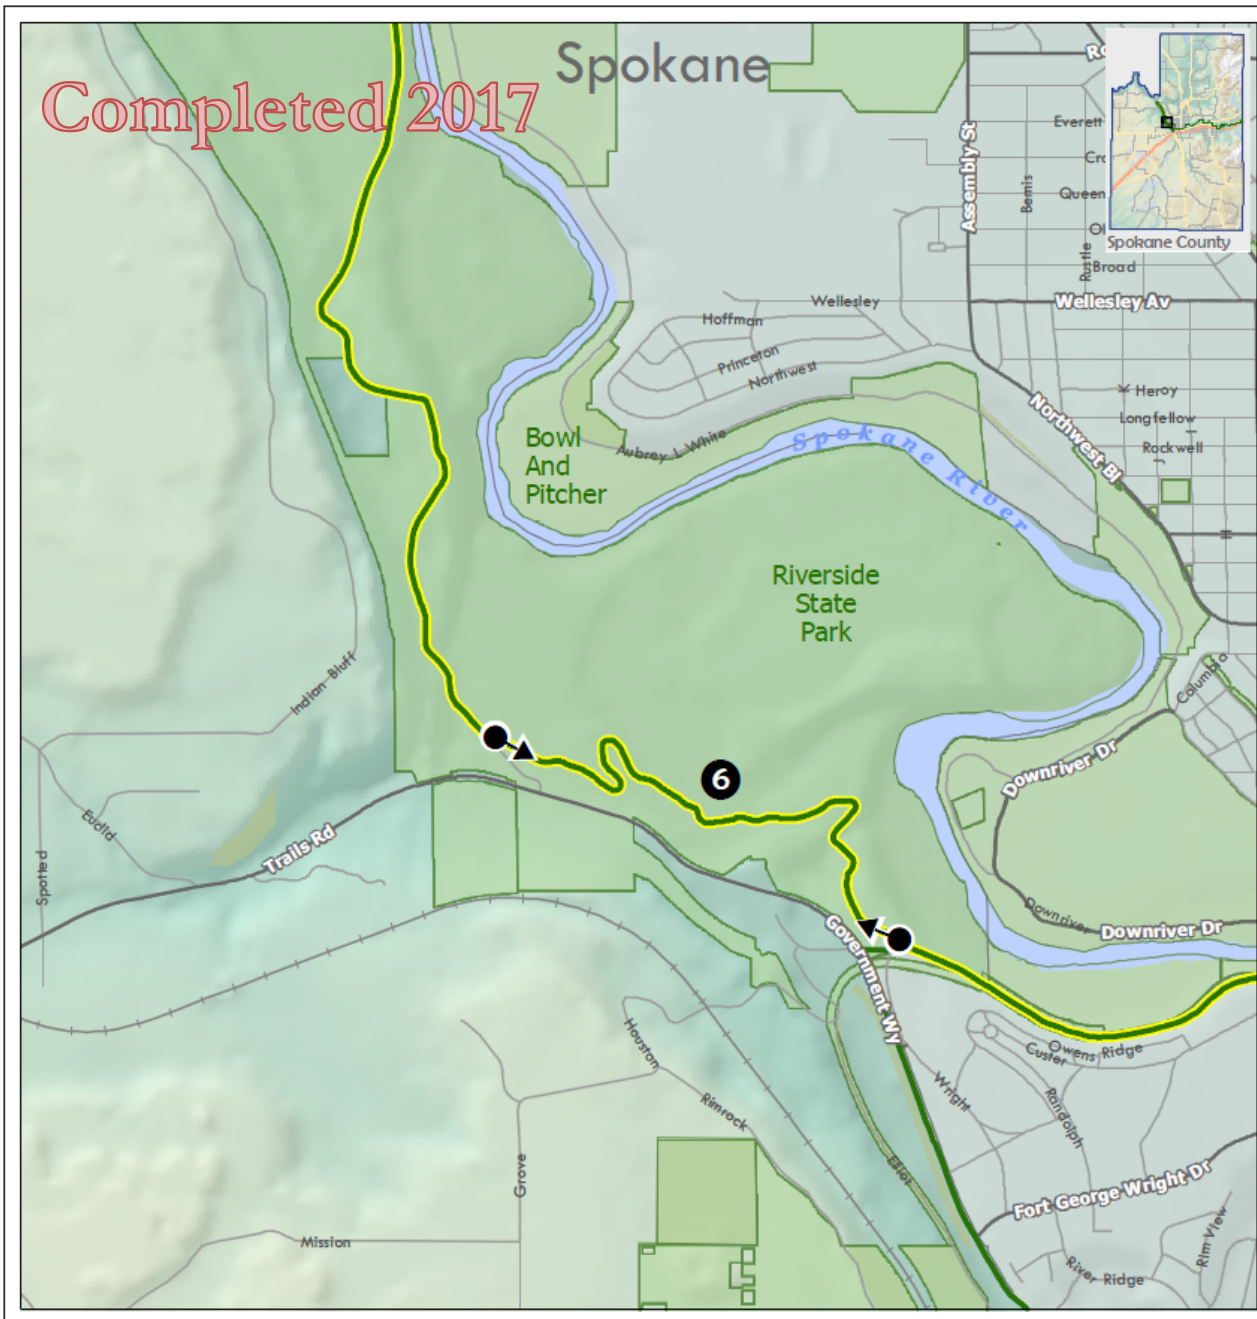
Maintenance Repairs Project 6

Repair large surface gaps in trail from previous failed crack repair project.

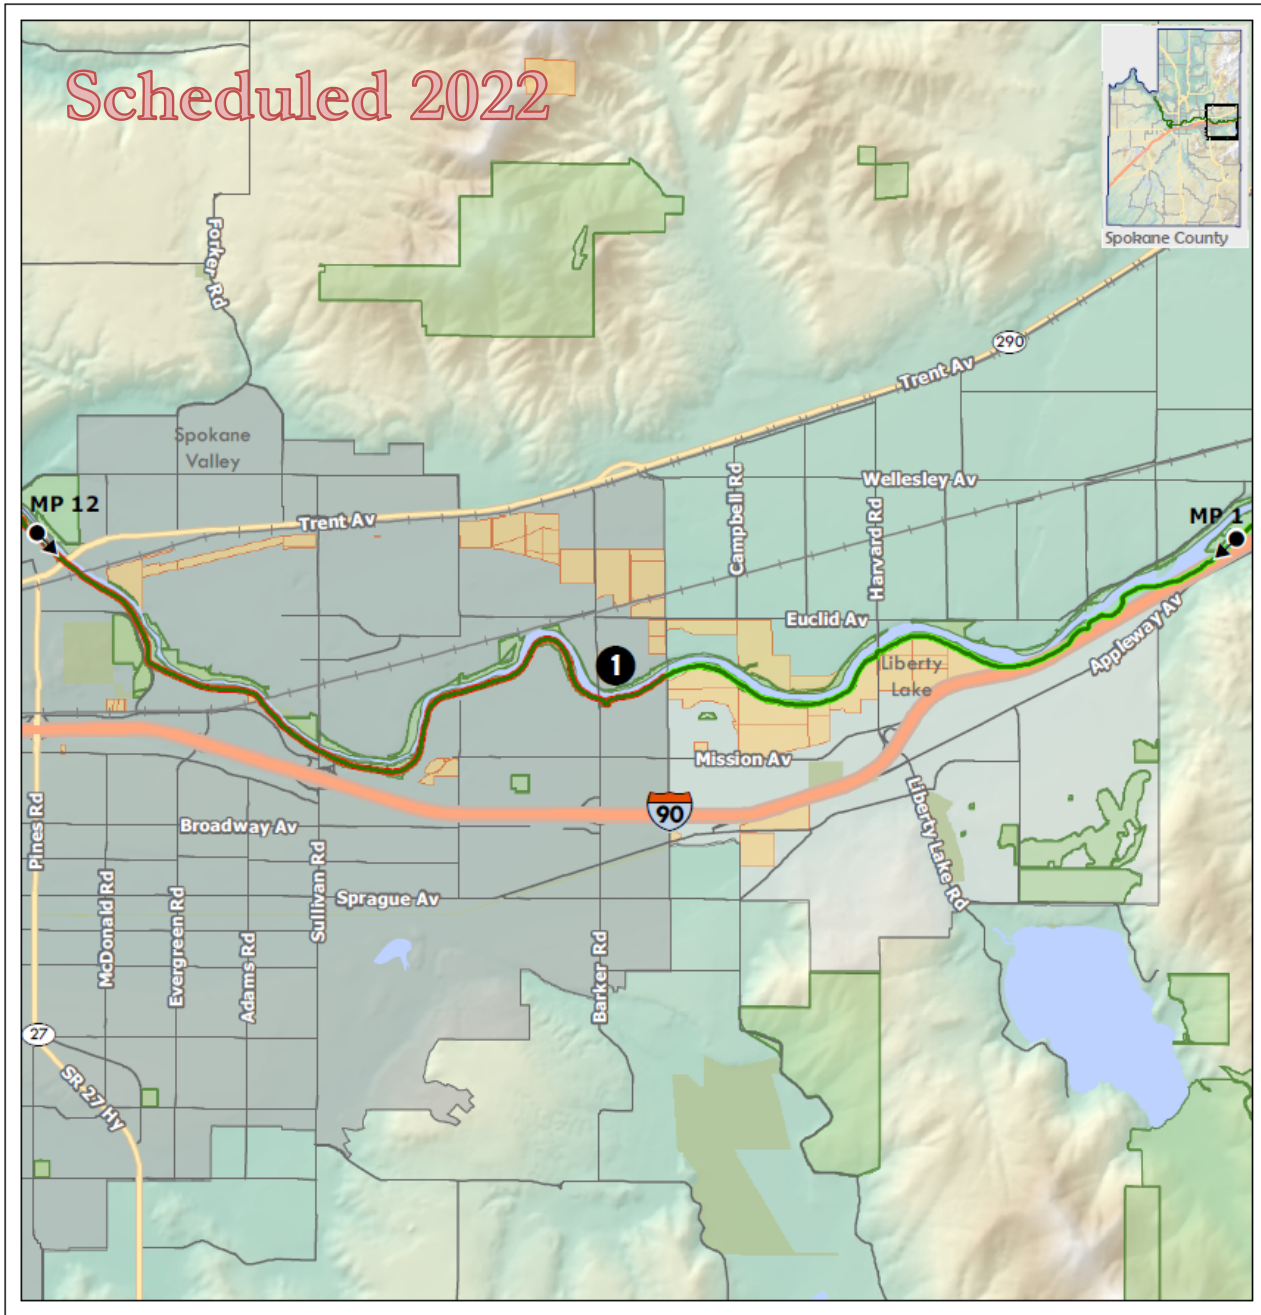
Map Page # 1 of 5

**Centennial Trail
Maintenance Plan
MP 1 - 12
Phase 1
Asphalt Overlay Project**

The surface repair projects were prescribed by Spokane County Public Works and timed in the Maintenance Investment Plan (MIP) to prepare the trail for an asphalt overlay. The asphalt overlay has been split into three phases of 12 miles each, excluding newer portions of the trail such as the Nine Mile extension, Kendall Yards and Convention Center segments. The asphalt overlay is designed to extend the surface life of the trail for another 15+ years and includes a 1.5” asphalt overlay with additional gravel brought in to raise the elevation of the shoulders accordingly.

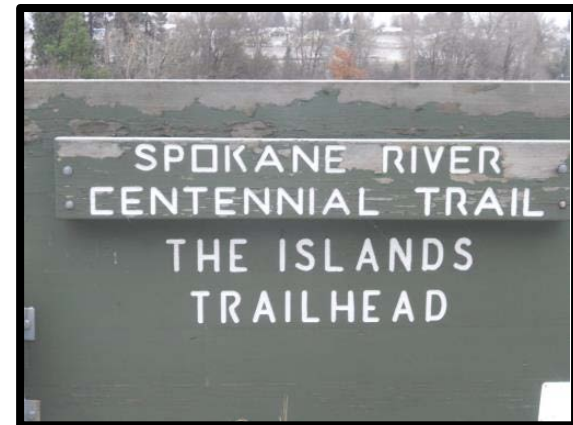
Example of a dated trailhead entrance sign needing replacement.

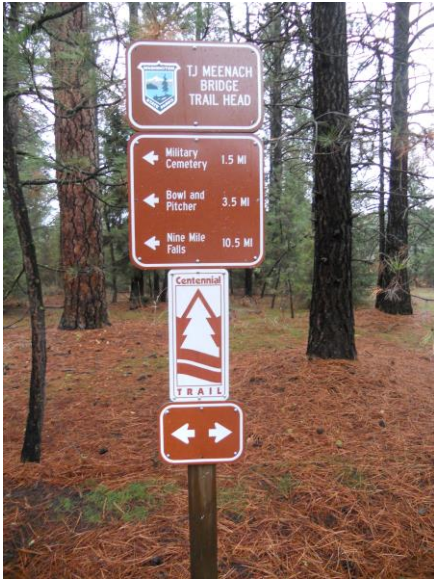
Good

Left: An example of a sign classified as good. There is no fading or cracking. The sign is legible and useful.

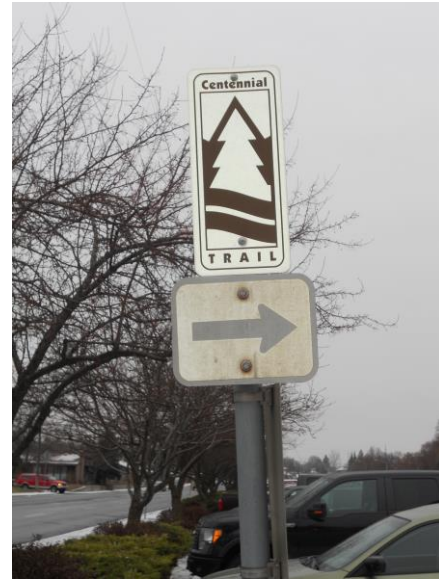
Fair

Right: An example of a sign classified as fair. Slight fading but otherwise still legible and useful.

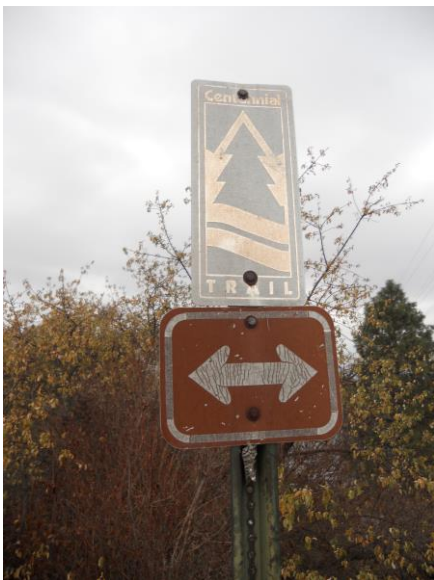
Poor

Left: A sign classified as poor. Sign is faded and paint is cracked. Sign still serves a purpose but is not appealing.

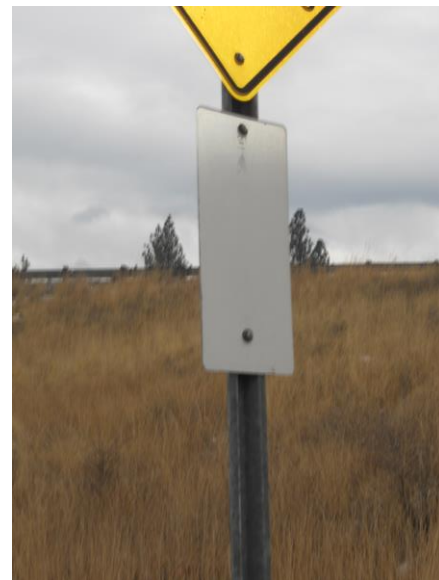
Needs Replace

Right: A sign classified as needs replace. Sign has lost its functionality and should either be removed or replaced.

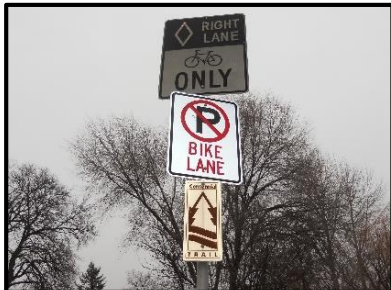
Left: Logo

Below are examples of the general sign classifications used in the sign inventory. Some poles have more than one sign; for example, a Centennial Trail logo with an I-90 bike route sign. Because this study was focused on the Centennial Trail and not bike routes in general, any pole with a Centennial Trail logo was classified as “logo” in the gen_type category. In addition, any sign that had a directional arrow (whether it was a green and white bike route sign or a Centennial Trail logo) was classified in the gen_type column as “directional.” The spec_type category differentiates between the two.

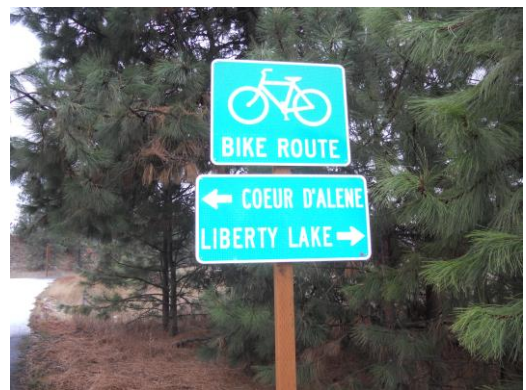
The State Line area is confusing for a variety of reasons. First, the freeway off-ramp signage coming from the west directs Centennial Trail users to the south, but there is also an I-90 bike route sign directing users to the north. The gravel parking area to the south of the freeway doesn't look official, and it's unclear whether it is a trailhead.

Second, the Liberty Lake State Line Trail is easily confused for the Centennial Trail where the two trails intersect. There is nothing to orient a user to the area, and there is no signage designating either trail.

Third, the freeway off-ramp signage coming from Idaho is insufficient. There is no signage designating the Centennial Trail, but there is an I-90 bike route sign directing auto traffic to the right.

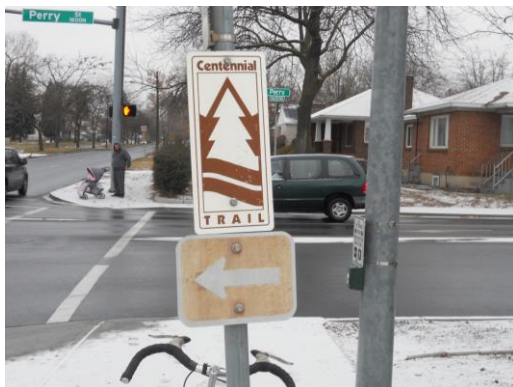
Mission St. Crossing

Clearly the Mission St. crossing is one of most difficult and dangerous arterial crossings along the Centennial Trail, and the Mission St. crossing project will drastically change the

signage needs of the area. Nevertheless, implementation of new signage should coincide with construction because good signage is crucial to ensure ease of travel during and after construction. There should be no lag period between the completion of the crossing and the implementation of signage. Identifying a safe and friendly detour around construction activity will be crucial.

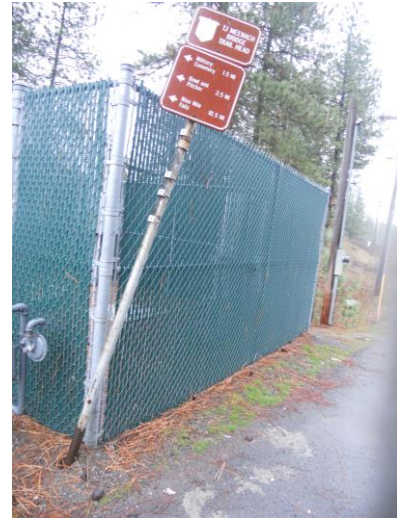
T.J. Meenach to Summit & Maxwell

The T.J. Meenach Bridge is another difficult portion of the trail to negotiate. Coming from the west, this is the first point that the trail goes onto a high volume arterial, and for a new user that is not entirely clear. New users might expect the trail to continue along the south/west side of the river. There should be a warning to users that they need to cross the bridge to stay on the trail. In areas like these with multiple decision points in a short distance, traditional signage can be confusing. Some other form of wayfinding should be considered for guiding cyclists and pedestrians under and across the bridge (possibly in the form of painted stripes, painted arrows, or pavement markers).

An equally confusing decision point is at Pettet St. and Maxwell Ave. where the trail takes a 90 degree right turn onto Maxwell Ave. There is no signage directing users to the right, and the presence of bike route signs along Pettet adds to the confusion.

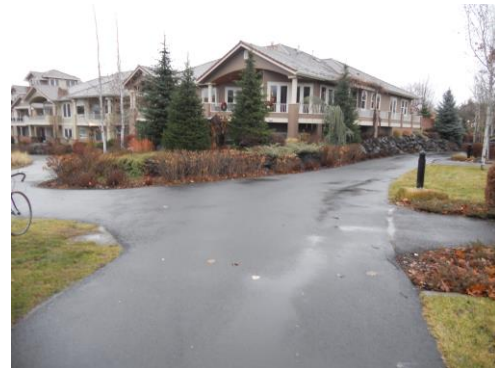
The painted lines near the Don Kardong bridge are faded and in need of repainting. It is also unclear whether the path that wraps around the condominium complex along the river is the official route. This is an area where the triple yellow wavy lines could be implemented to guide users in the desired direction.

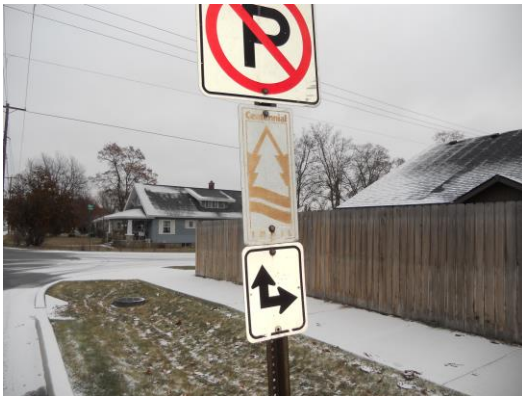
E. Upriver to E. Maringo

The section between E. Upriver Dr. and the East Maringo Trailhead is another difficult section. Heading east on E. Upriver Dr. it is not entirely clear that the trail takes a right turn onto Farr. Rd. The picture to the left shows that intersection. Although, the arrow is the official indication of a right turn, it is not intuitive. A simple single arrow pointing to the right might be more effective.

Heading west from the E Maringo Trailhead, there is no sign indicating that the route takes a right turn onto Farr Rd.; a new user would probably expect to continue traveling straight on E. Maringo.

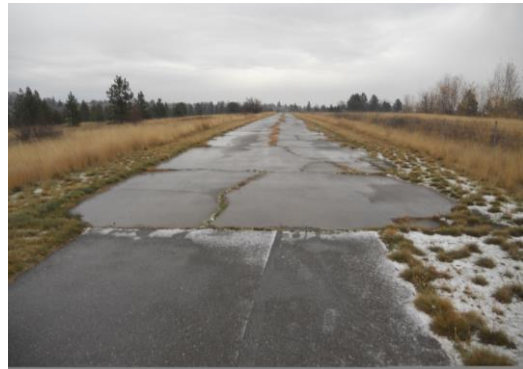
Surface change just before mile marker 1

Just before mile marker 1 the surface changes from smooth pavement to concrete with wide cracks, which is potentially dangerous for cyclists. There should be some warning to riders at least 30-60 feet in advance.

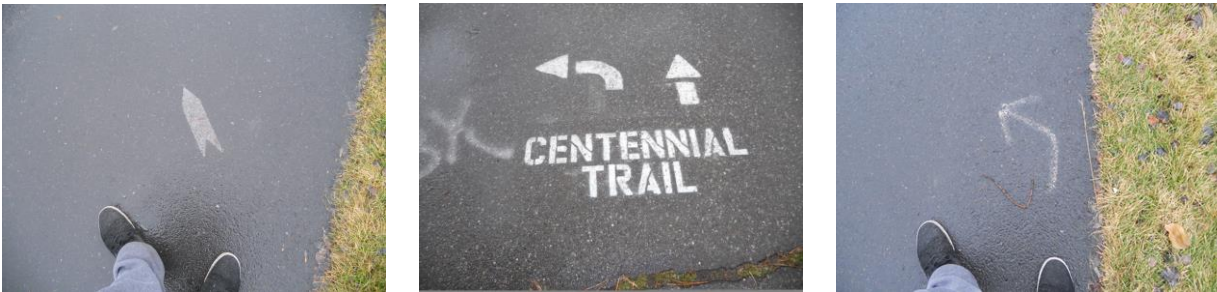
Above: Users of the Centennial Trail have already seen the utility of pavement wayfinding as these spray-painted directional arrows demonstrate.

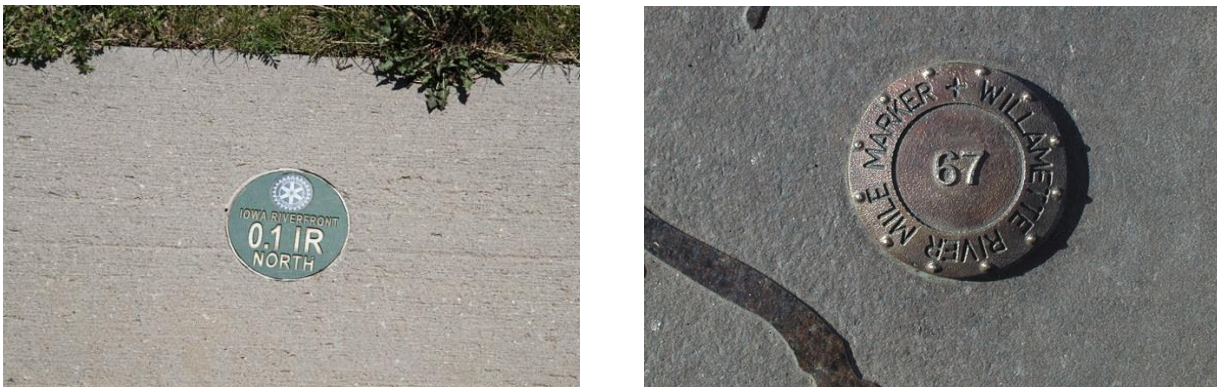
Above: Two examples of pavement markers that can be used to confirm to users that they are on the trail.

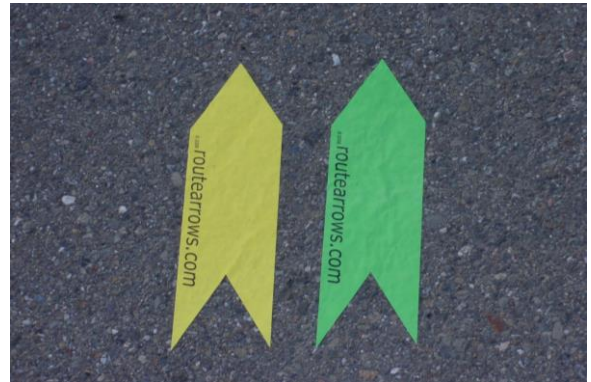
Right: An example of temporary, inexpensive pavement decals that are usually used to mark race courses, which could easily be used to test the effectiveness of ground-level wayfinding

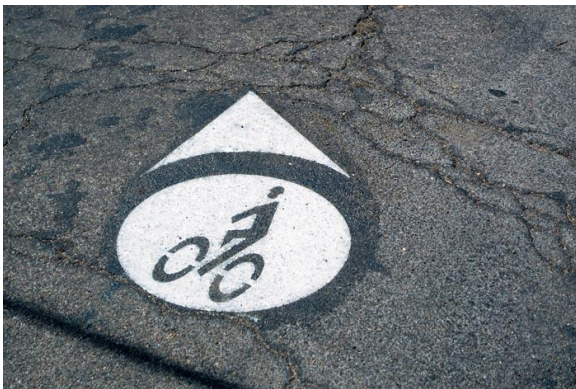
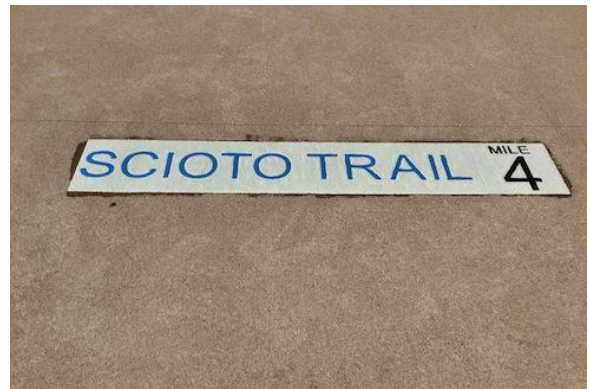
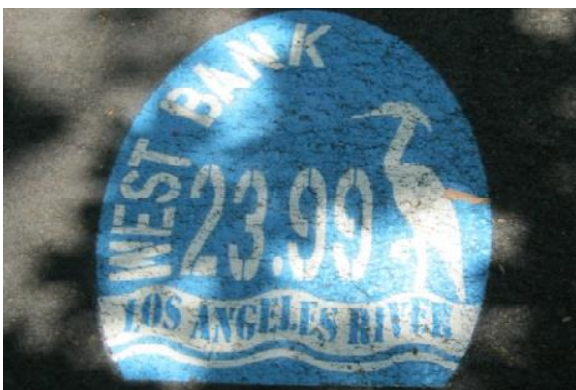
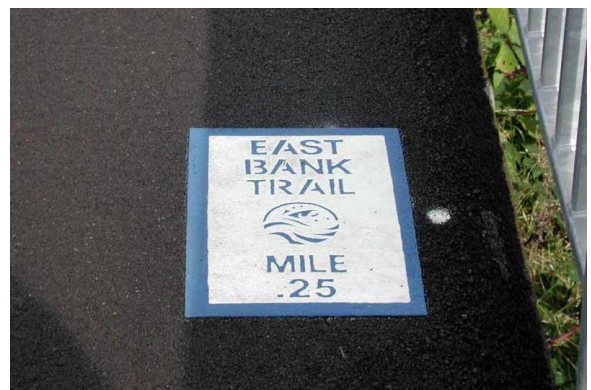
Below: Several examples of permanent pavement decals that could be used to mark the Centennial Trail in open spaces like Riverfront Park where signs may not be as effective. They can also be used before and after decision points to direct users and confirm their choices. Many of these pavement decals are fully customizable, meaning the current logo could be used. They are also simple and inexpensive to apply.

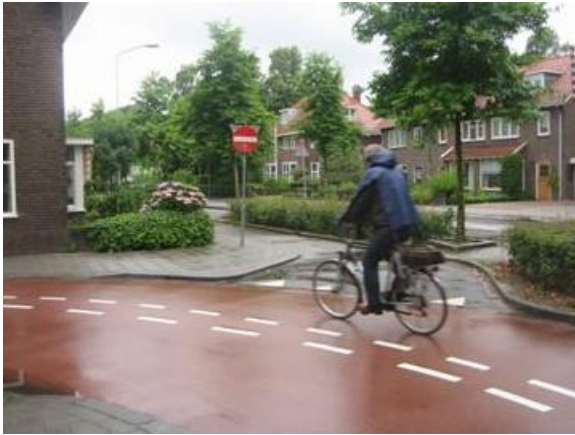
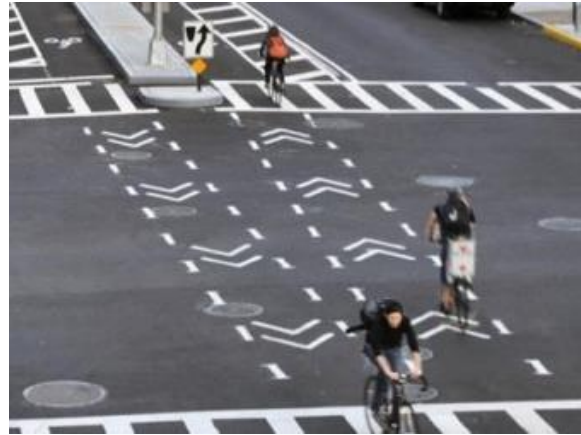
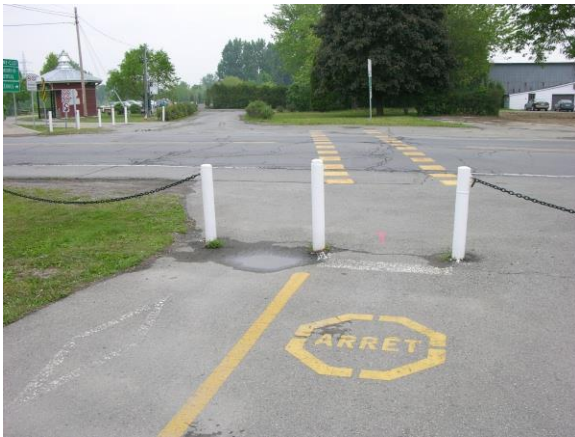
Left and Above: A combination of these painted markings and surfaces could be utilized in select areas along the trail. This type of infrastructure is highly effective in areas where signs may be too ambiguous and where users need to make decisions quickly.

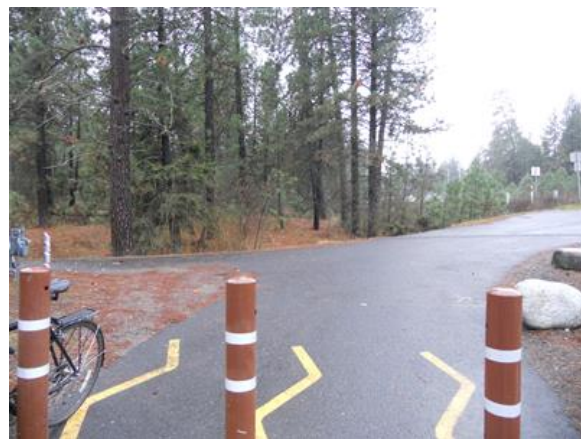
Right: The triple yellow wavy lines already in use on the Centennial Trail are a great way to guide users through confusing sections. They could even be extended to cover longer distances to designate an entire section of trail (especially where the trail changes from a separated to a shared use path).

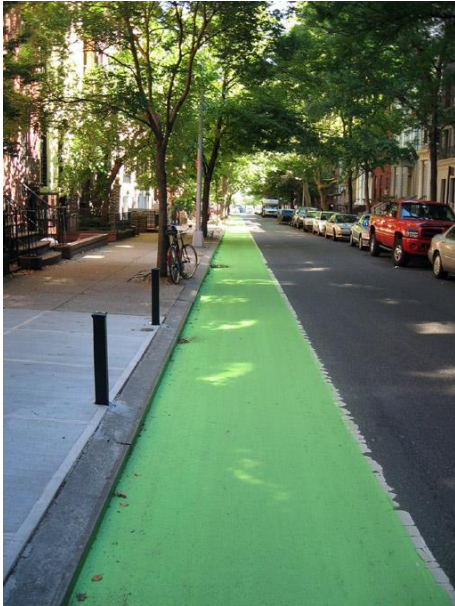
Left: A long term and effective solution would be to paint entire sections of the trail in the difficult to navigate areas (similar to the green paint used in urban bike lanes).

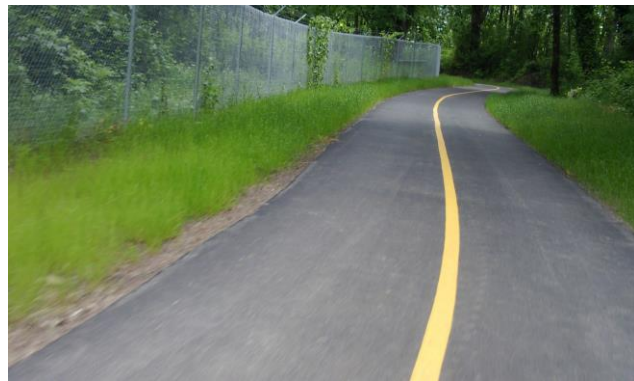
Below: A single stripe improves safety, guides users at decision points, and confirms to users that they are on the trail (with much less paint).

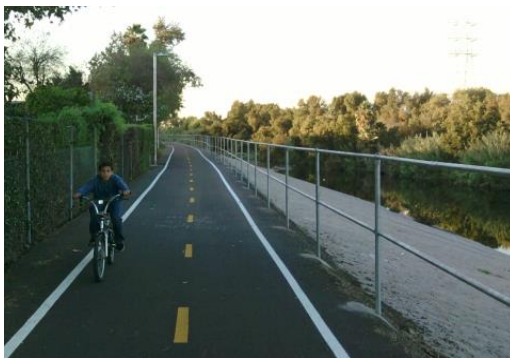
Left: Regular street striping can also be used to improve safety and clearly identify the Centennial Trail.

Right: This pavement stores energy from the sun's UV rays during the day. At night the surface releases the energy, allowing the particles to glow in the dark. This could be a viable long-term solution for nighttime wayfinding in areas that get nighttime use. It would certainly be an attraction and improve safety.

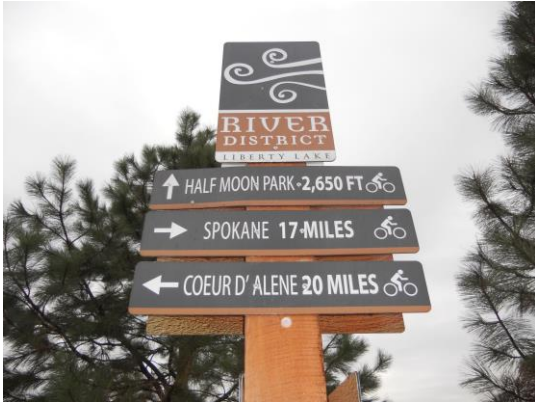
Left: A great example of wayfinding along the Centennial Trail that catches the eye and displays information effectively. The only shortcoming of this sign is that it doesn't state that the trail that gets you to the destinations is the Centennial Trail.

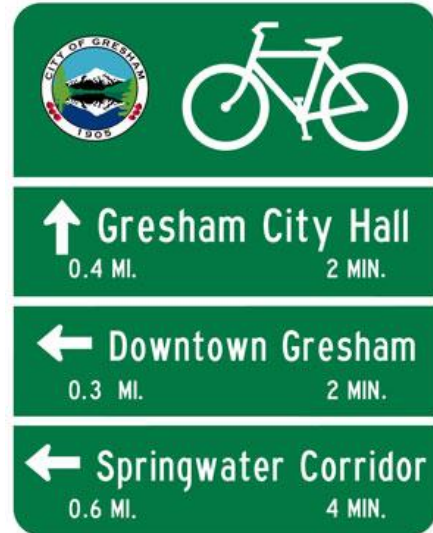
Right: A traditional bike route wayfinding sign with distances and time of travel by bike.

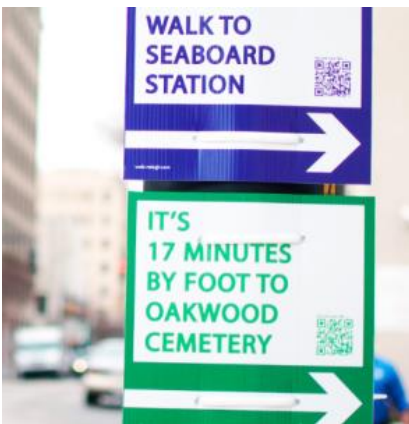
Left: Non-traditional signage indicating distances and time of travel.

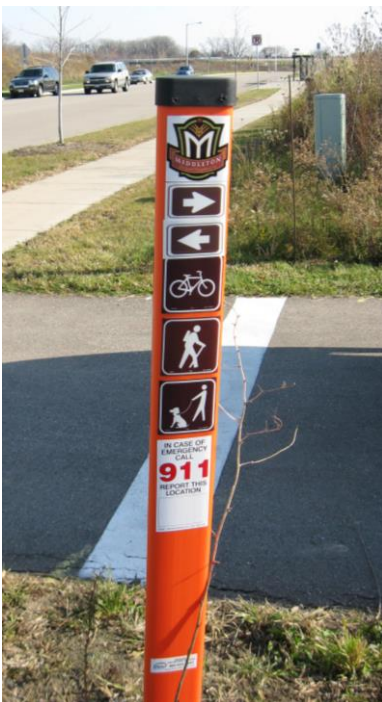
Left: Posts like these may be less expensive and just as effective as traditional metal signs on metal posts.

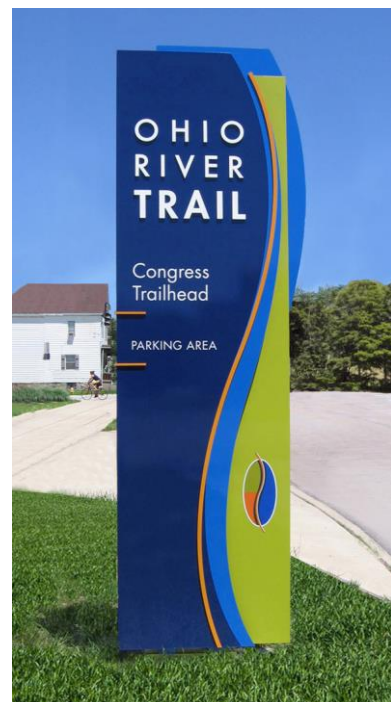
Right: Large, well-designed markers like these help bring an identity to a trail. Markers like these could be highly effective at major access points like Riverfront Park, Kendall Yards, or at State Line.

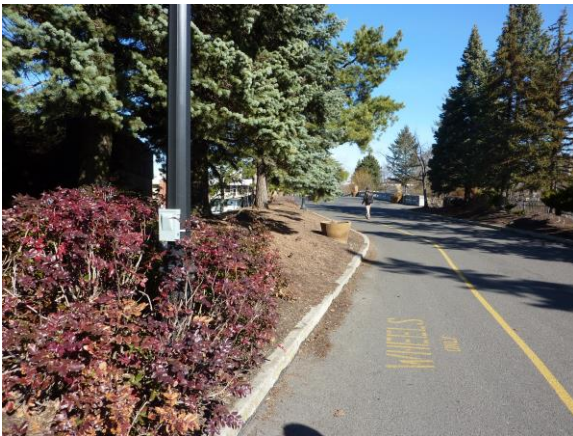
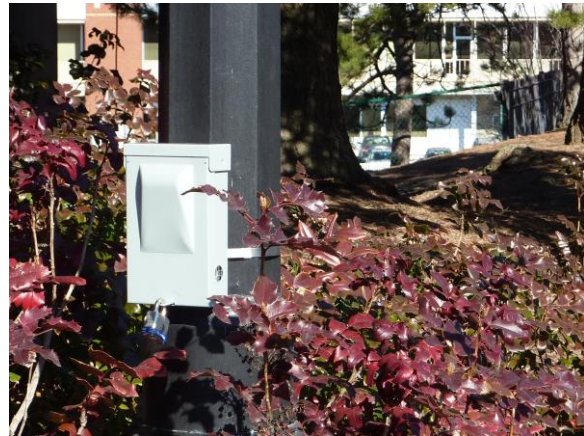
Below: The TRAFx counters can be placed in gray utility-like boxes and attached to poles. They have roughly a 20 foot range.
